# **GALLATIN GATEWAY GRAVEL PIT PROJECT**

**DSL - AMRB No. 93-007**

## **FINAL REPORT**

**November 22nd, 1993**

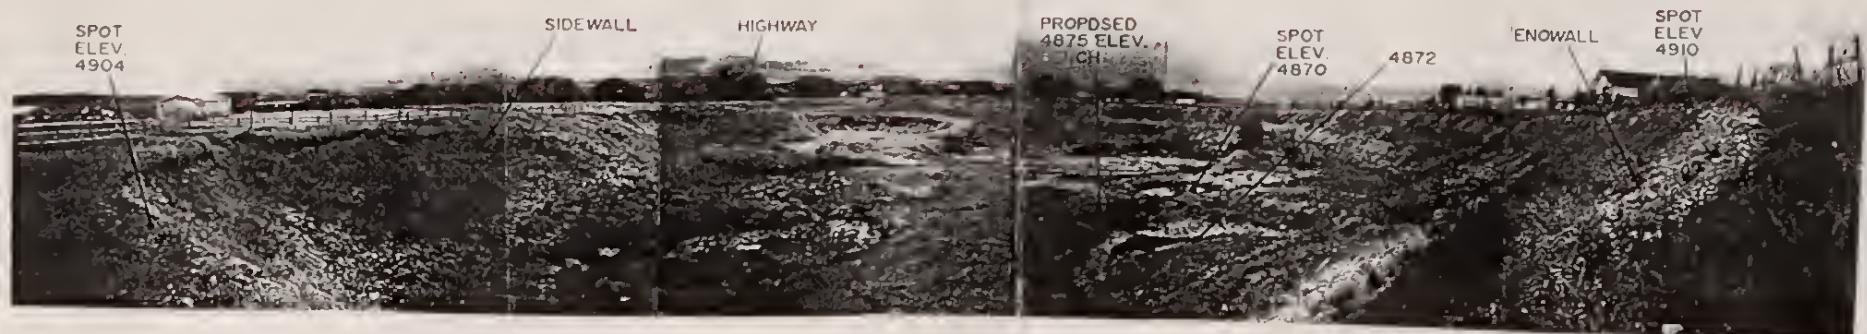
PHOTO 1

Looking northwest towards the highway. The endwall is on the right and the southern sidewall is on the left of the photo. The lower proposed bench (at 4875' elev.) is in the center between the endwall and southern sidewall. The maximum fill on this bench is just over 5 feet and the maximum cut within this bench is about 7 feet.

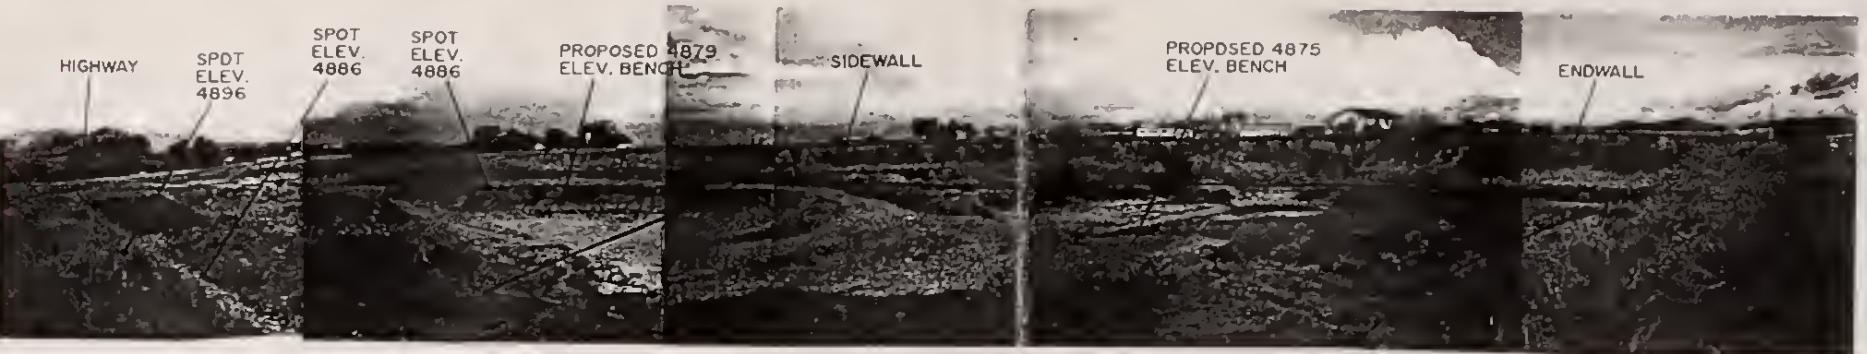
PHOTO 2

Looking north at the 2 current benches. The two proposed benches (4879 and 4875 elev.) can also be seen.

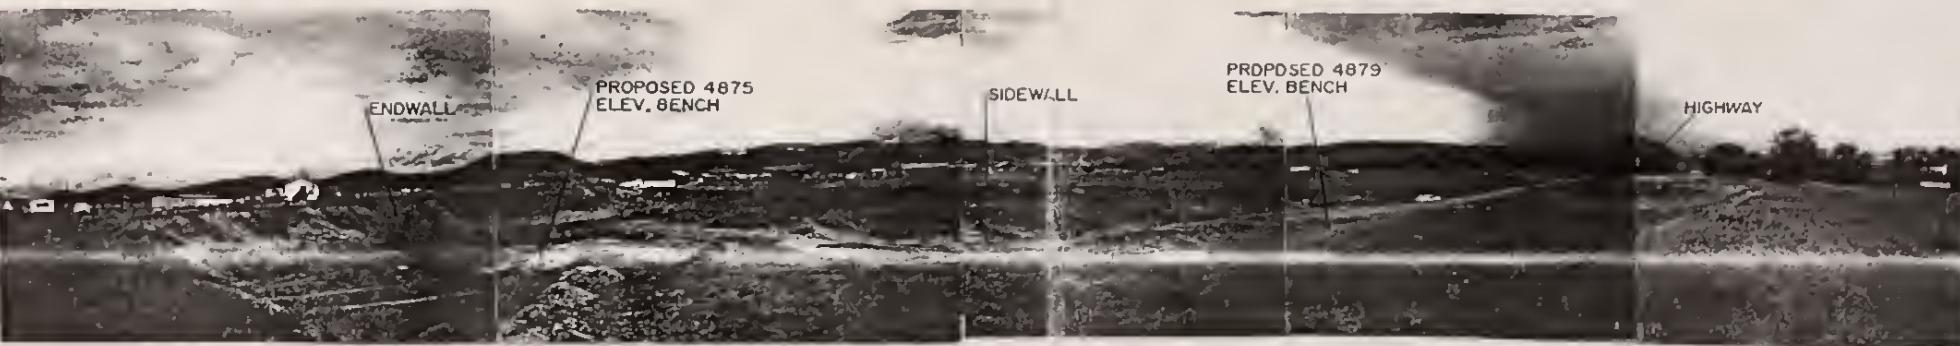
PHOTO 3

Looking south-southwest across the gravel pit. The lower bench is on the left and the upper bench is on the right of the photo.

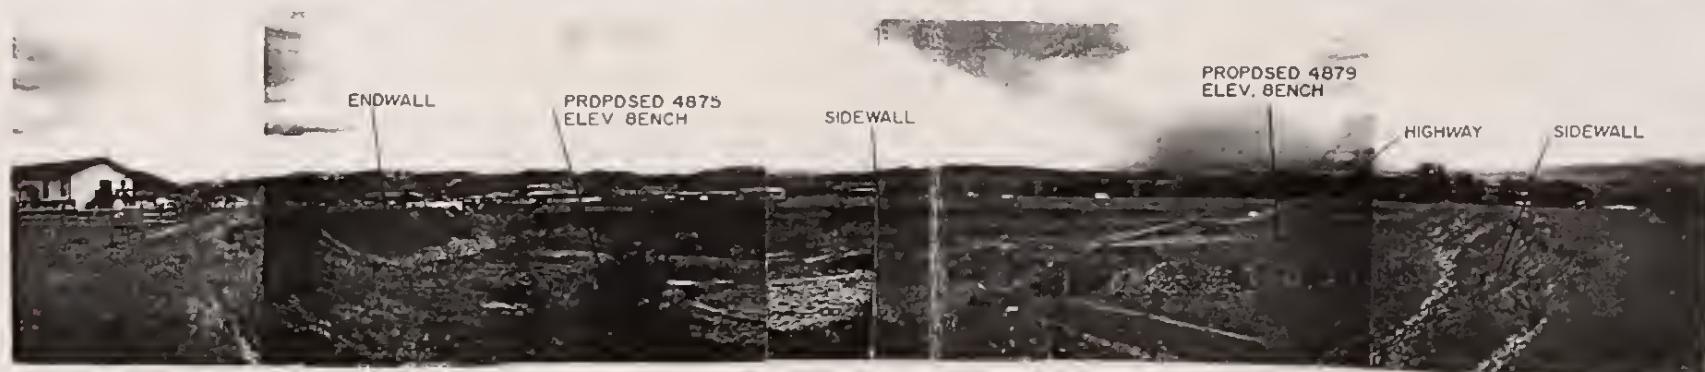
PHOTO 4

Looking southwest across the pit. The northern sidewall is on the right. The endwall is on the left and the southern sidewall is in the middle of the picture.

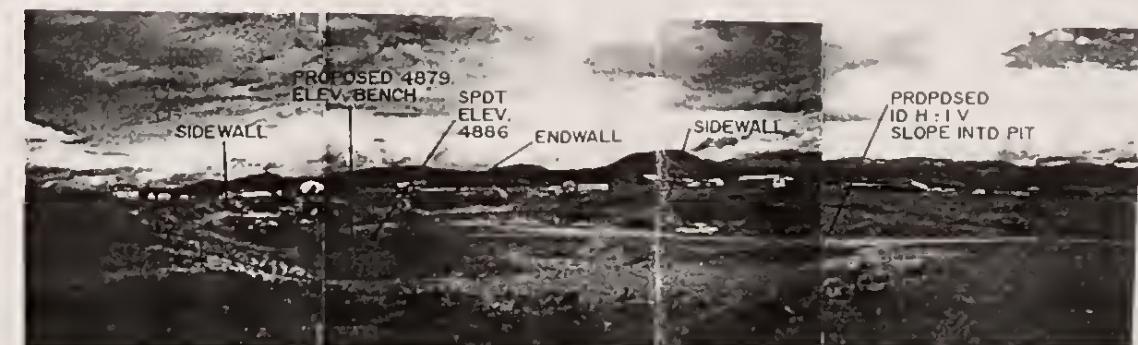
PHOTO 5

Looking east-southeast into the pit from the slight hill on the northern side of the pit at the entrance. The proposed entrance slope is on the right of this photo. This will be cut at a 12H:1V until it intersect the new 4879 foot bench elevation. This upper bench will require from 7 to 9 feet of cut.
